Information Paper

Tiled floors with underfloor heating

A guide to minimising and repairing cracking

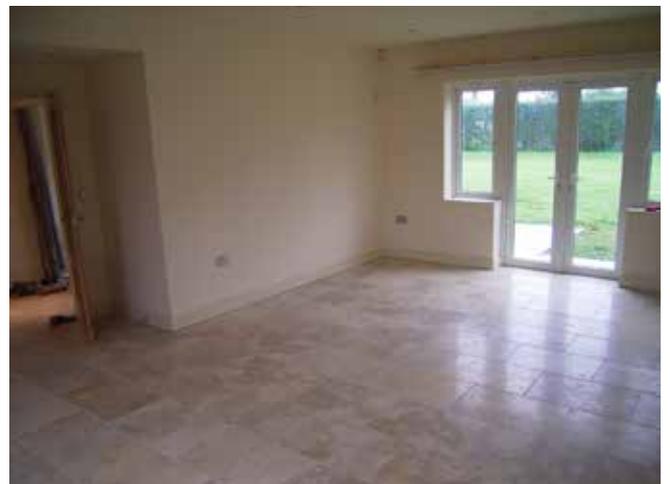
Figure 1: Stone tiles installed with underfloor heating

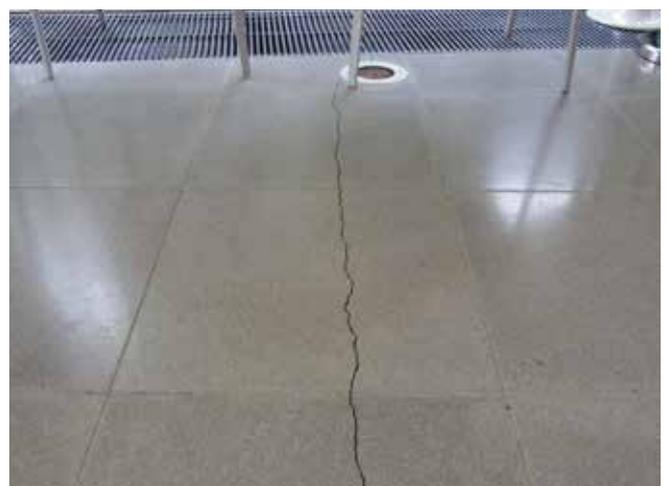
Figure 2: Crack spanning multiple tiles

A common cause of problems in rigid tiled flooring is cracking, associated with underfloor heating. Over the years, BRE has investigated numerous cases where stone or ceramic tiles have been laid onto a screed only for cracks to appear in the tiles and along grouted joints within a few weeks of operation of the heating system.

The tile cracks and open joints are almost always caused by movement of the screed at a pre-existing crack or, in some instances, a 'day' joint in the screed. This movement, although only a fraction of a millimetre, is sufficient to crack even thick granite slabs.
