Good Building Guide

Building damp-free cavity walls

Barry Reeves and Chris Scivyer

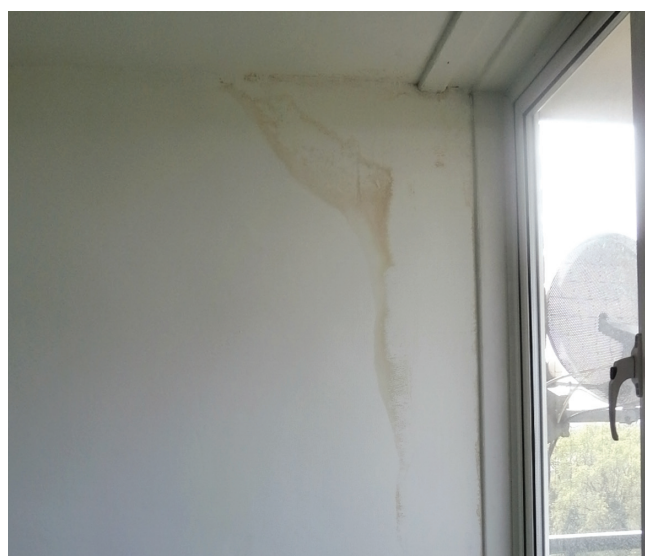
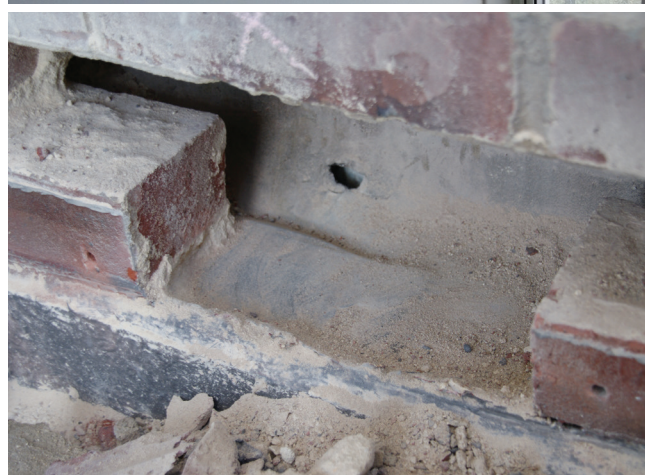
Figure 1: Damage to a ground-floor flat caused by rain penetrating the inner leaf of a cavity wall via a torn and debris-filled cavity tray to a cavity wall of a flat upstairs
